# Intel<sup>®</sup> Pentium<sup>®</sup> 4 Processor Specification Update

Release Date: November 2001

Order Number: 249199-015

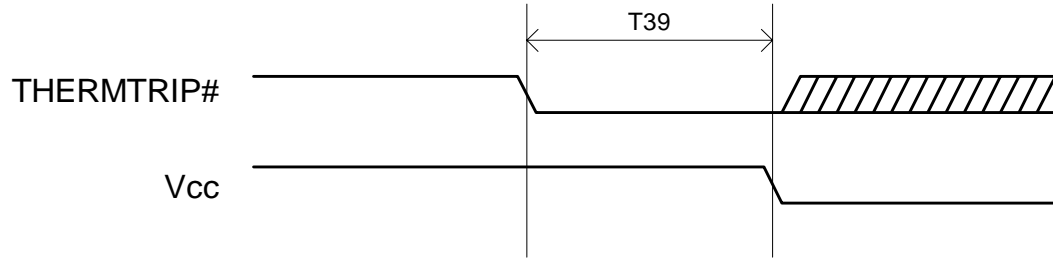
The following figure will be added as Figure (new). THERMTRIP# Power Down Sequence

Assertion of THERMTRIP# (Thermal Trip) indicates the processor junction temperature has reached a level beyond which permanent silicon damage may occur. Measurement of the temperature is accomplished through an internal thermal sensor which is configured to trip at approximately 135°C. Upon assertion of THERMTRIP#, the processor will shut off its internal clocks (thus halting program execution) in an attempt to reduce the processor junction temperature. To protect the processor, its core voltage ( $V_{CC}$ ) must be removed following the assertion of THERMTRIP#. See Figure (new) and Table 13 for the appropriate power down sequence and timing requirements. Once activated, THERMTRIP# remains latched until RESET# is asserted. While the assertion of the RESET# signal will de-assert THERMTRIP# , if the processor's junction temperature remains at or above the trip level, THERMTRIP# will again be asserted after RESET# is de-asserted.

$T39 < 0.5$  seconds

Note: THERMTRIP# is undefined when RESET# is active
