Intel[®] Core[™]2 Extreme Processor QX9000^Δ Series and Intel[®] Core[™]2 Quad Processor Q9000^Δ, Q9000S^Δ, Q8000^Δ and Q8000S^Δ Series

Specification Update

— on 45 nm Process in the 775-land LGA Package

January 2013

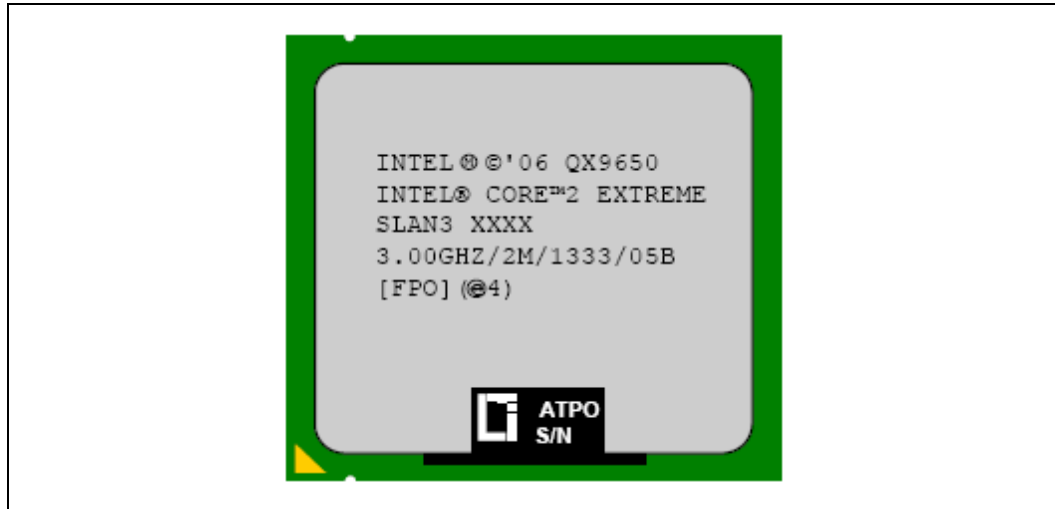
Figure 1. Processor Top-Side Markings Example (Intel® Core™2 Extreme Processor QX9650)

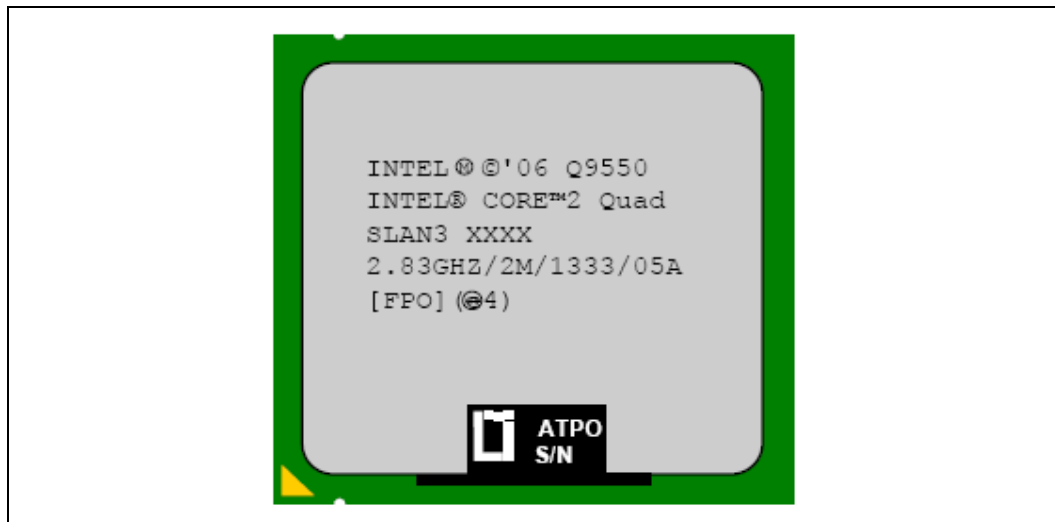
Figure 2. Processor Top-Side Markings Example (Intel® Core™2 Quad Processor Q9000 Series)
